THE UNITED MINE WORKERS OF AMERICA, AFL-CIO/CLC

REPORT ON THE

Sago Mine Disaster

OF JANUARY 2, 2006

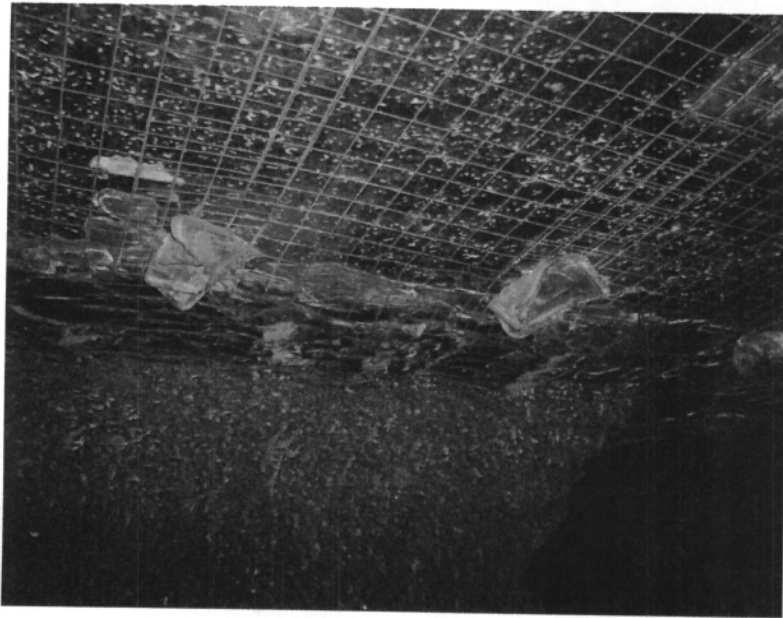
Wire screen, such as that in the picture to the left, was common in many areas of the Sago Mine. The West Virginia Office of Miners Health, Safety and Training required mine management to screen almost the entire roof area in the 2nd North Mains Section just prior to abandoning the Section.

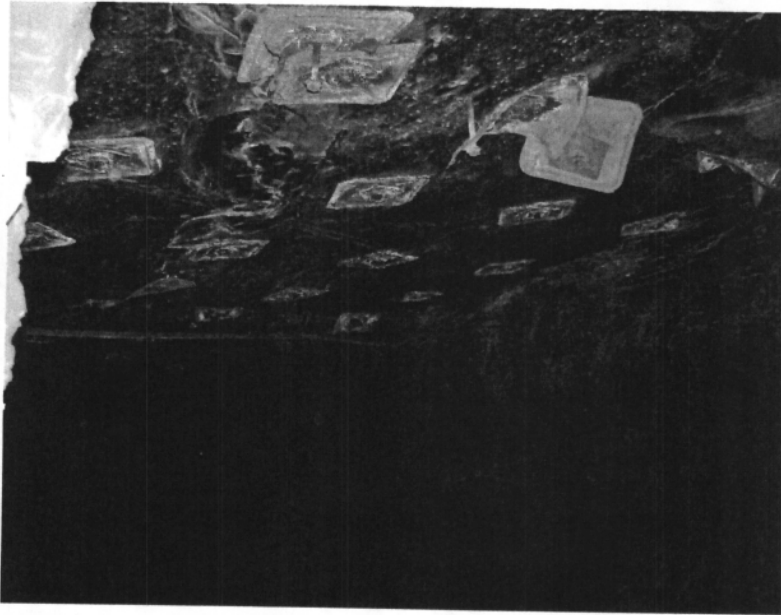
In areas that did not require wire mesh, management was required to install large roof bolt plates (pie pans) to support the local roof. Supplemental supports, such as cable bolts, were also required in many areas of the mine to address adverse conditions, including the 2nd North Mains Sections.

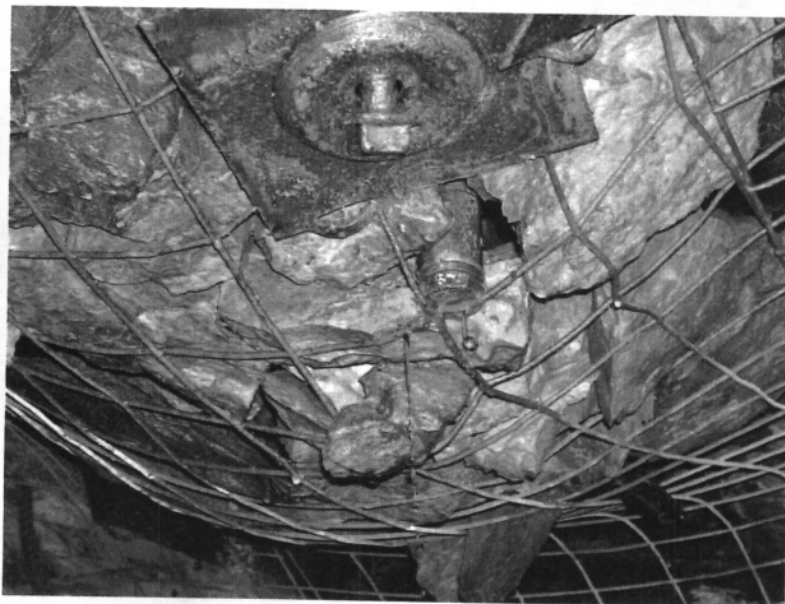
Continuously deteriorating roof conditions after an area has been supported by roof bolts and screening causes pressure on the supports as demonstrated in the picture. These stresses can cause the screening, bolts and roof to rub together or break under the pressure, potentially causing frictional arcing.

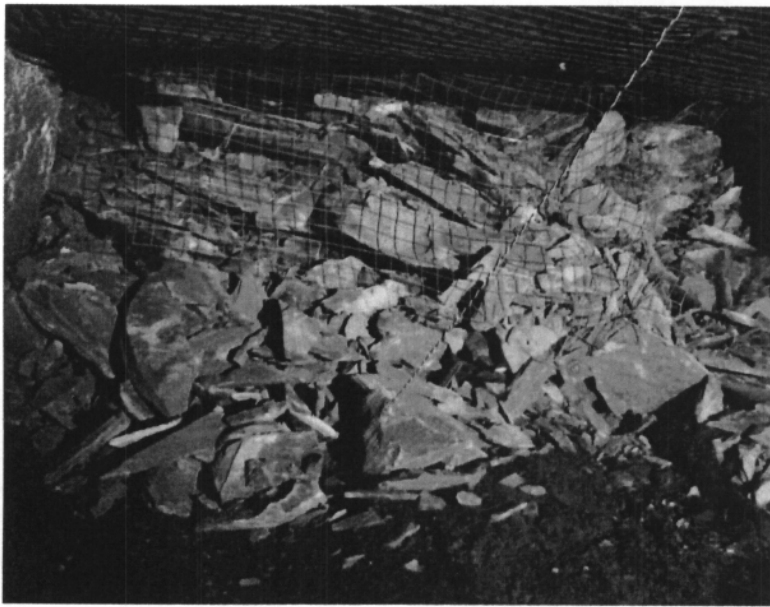
Roof falls are a hazard in the mining industry. The picture to the left was taken in the 2nd North Mains Section after the explosion. The investigation revealed numerous falls in the area that had occurred after it was sealed. Roof falls have been documented to cause frictional arcing.

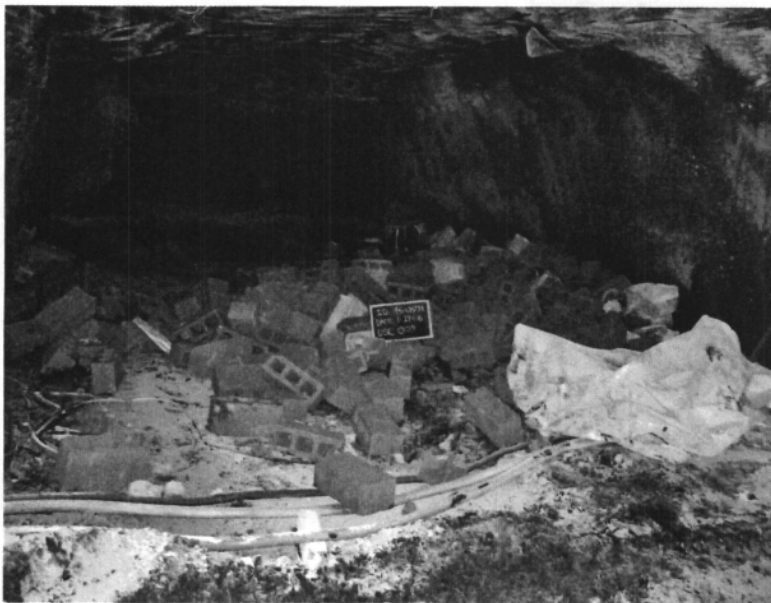
The remains of a concrete block wall after being struck by the forces of the explosion. It is still possible to see some of the blocks strewn around the area.

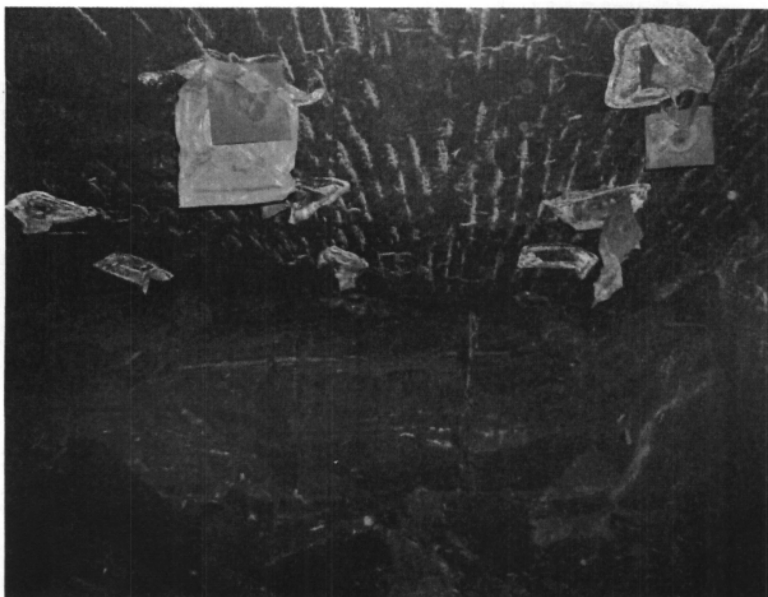
Damage to the roof supports (pie pans, roof bolts and plates) from the forces of the explosion. There is a roof fall in the foreground.

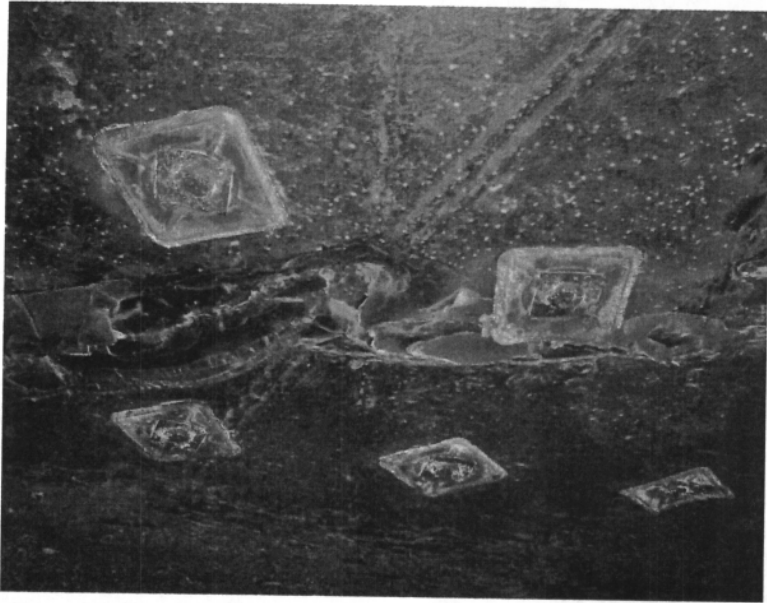
During the investigation the marks in the roof pictured at the left drew much attention. The "anomaly," as it became known, was later determined to be a fossil.

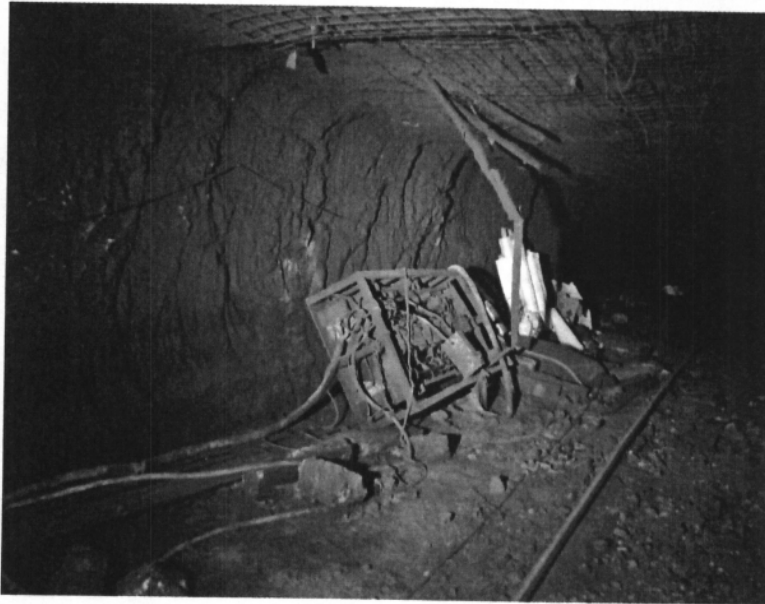
Damaged charging station located in the mains outby the sealed area.

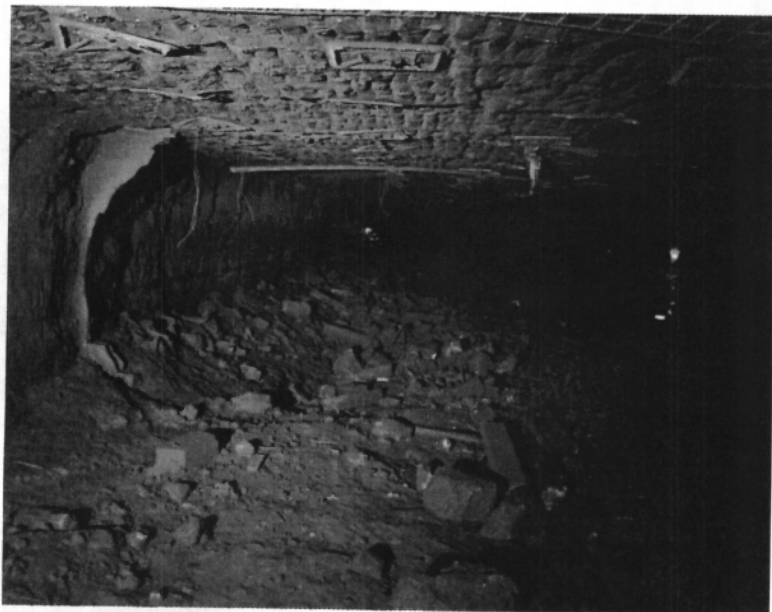
Area inby the Omega Block seals after the explosion. Debris is scattered over the entire area and a thick layer of soot covers everything.

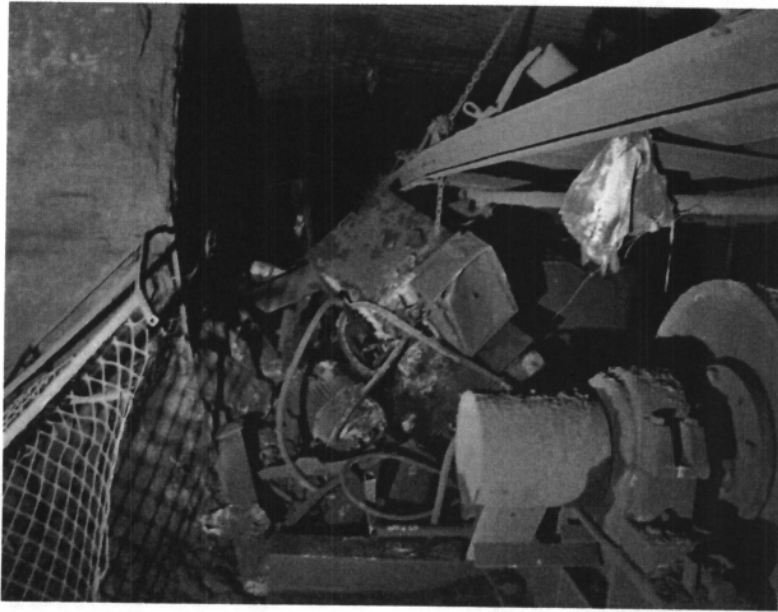
Damaged 2nd Left belt drive. The drive was located at 58 block, approximately the location where the miners were forced to abandon their first rescue attempt.

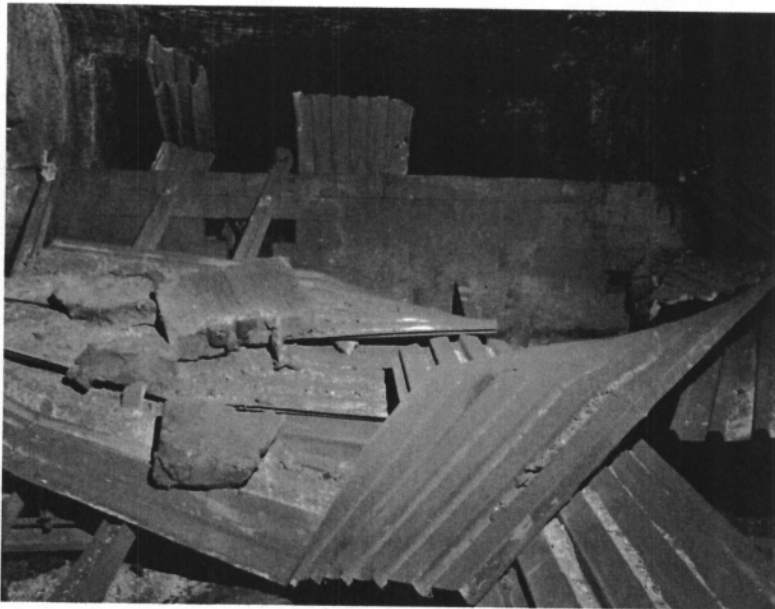
Ventilation overcast destroyed by the forces of the explosion.

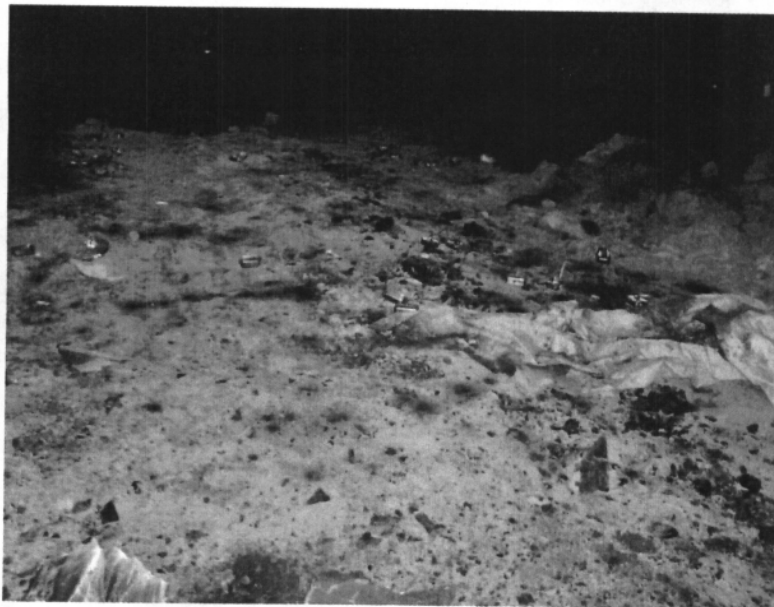
Discarded pieces of the 2nd Left crews SCSR's were found in the #7 entry at about the eleven block. The picture indicates all the miners donned their rescuers at the same time at this location.

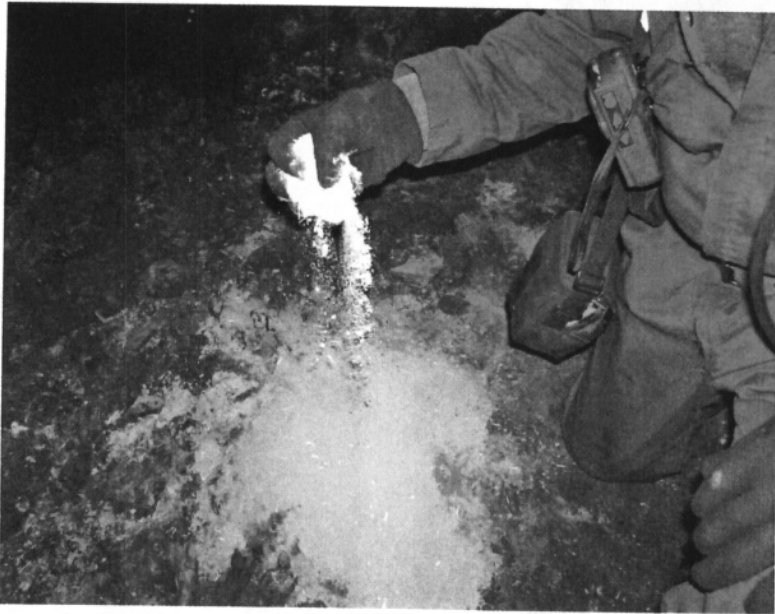
The explosion in the sealed area produced heat and extreme forces. These factors pulverized nine of the ten Omega Block seals. The remaining seal, located in the #1 entry, failed catastrophically.

The forces of the explosion completely destroyed the Omega Block seal. Fine powder and dust was all that remained of most of the seal material.

5. The use of Omega Blocks should not be permitted as a ventilation control in any underground mining operation.
6. The National Institute for Occupational Safety and Health (NIOSH) recently released a draft report entitled, "Explosive Pressure Design Criteria for New Seals in U.S. Coal Mines." The UMWA fully endorses the report and its recommendations, as follows:

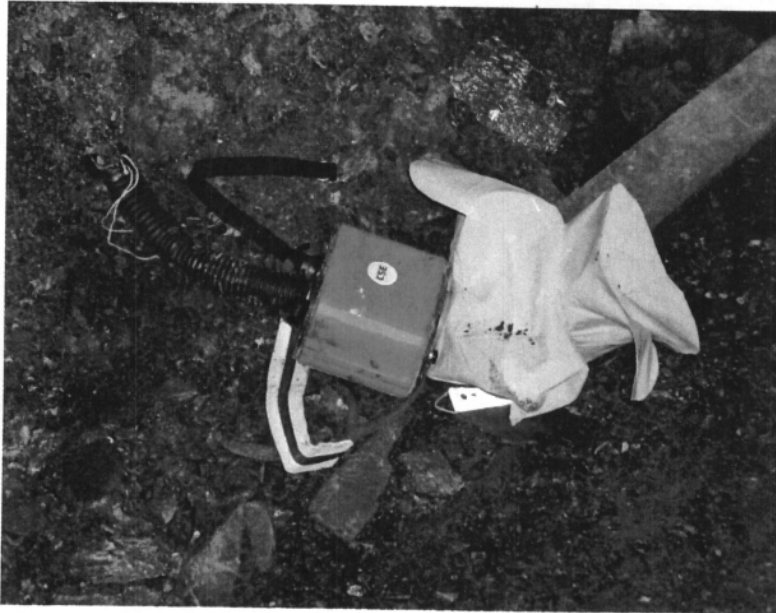
Discarded SCSR found in the 2nd Left Section.

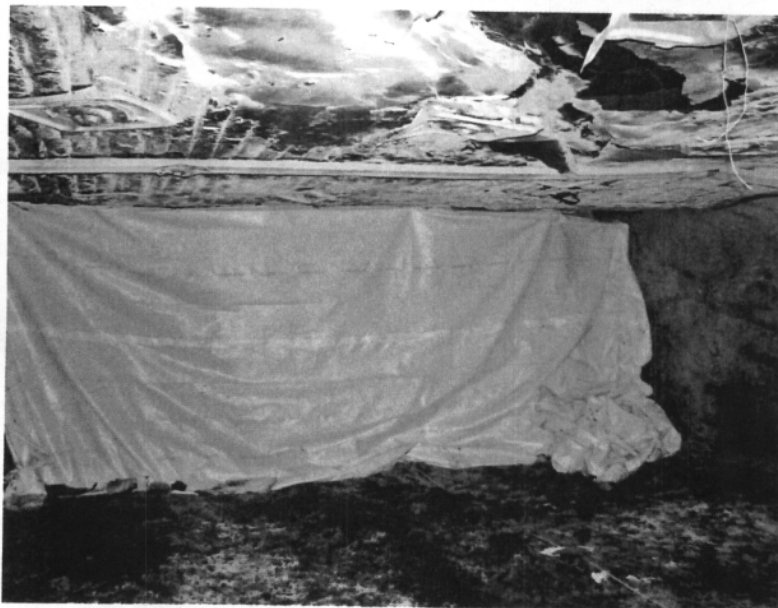
Outby view of the barricade constructed by the 2nd Left crew in an attempt to isolate themselves from the contaminated mine atmosphere.

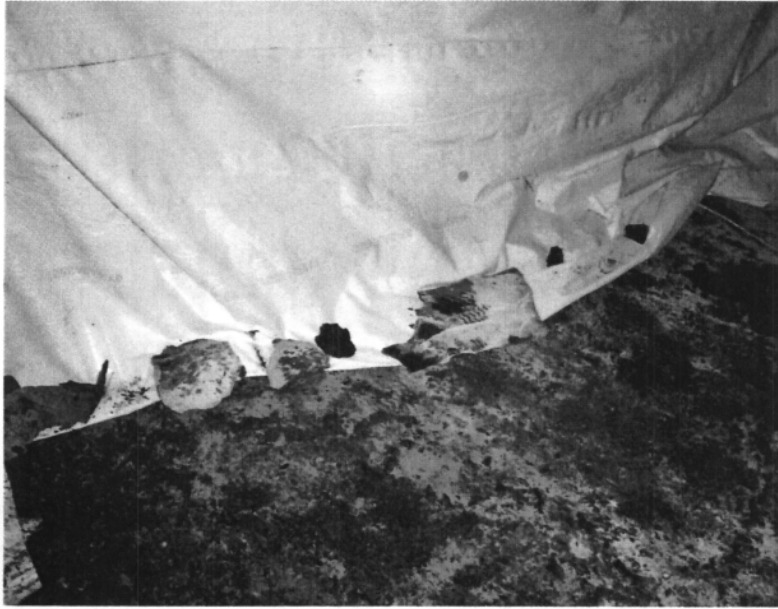
View of the barricade from the inby side.

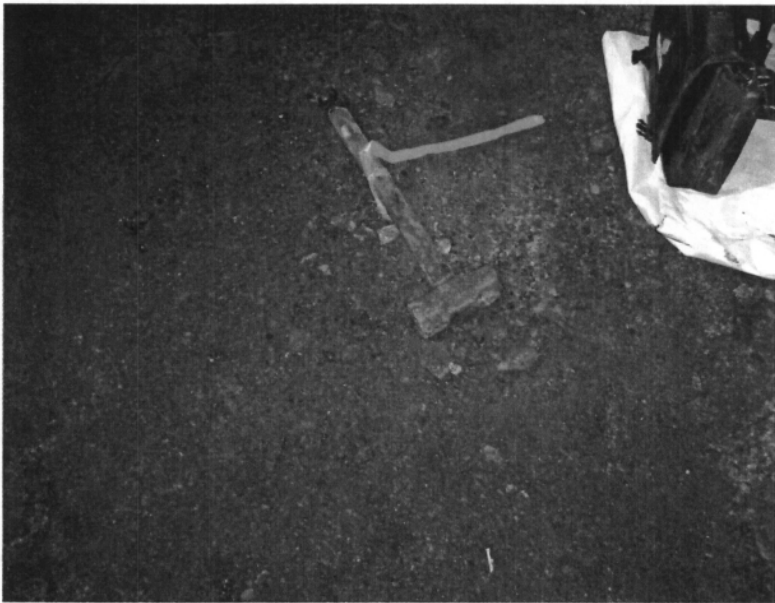
Sledge hammer used by the 2nd Left crew to signal their location to the surface.

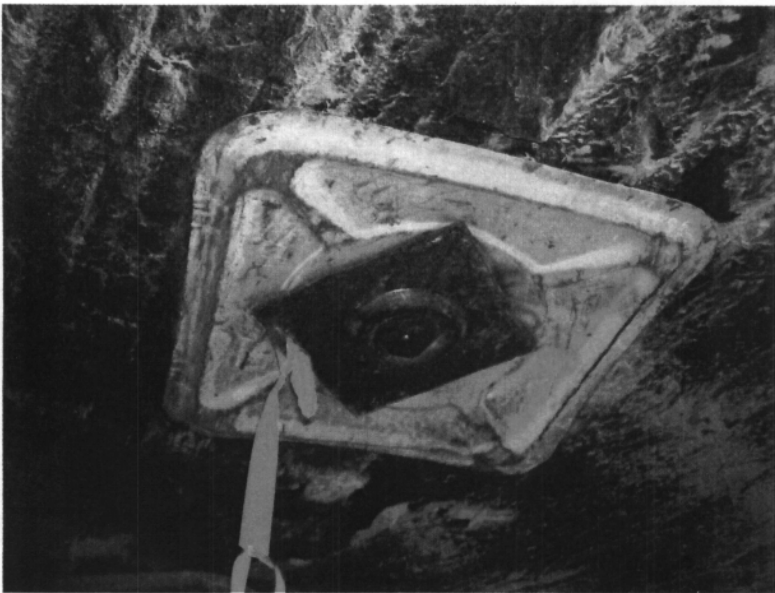
Roof bolt the 2nd Left crew hit to signal the surface of their location.

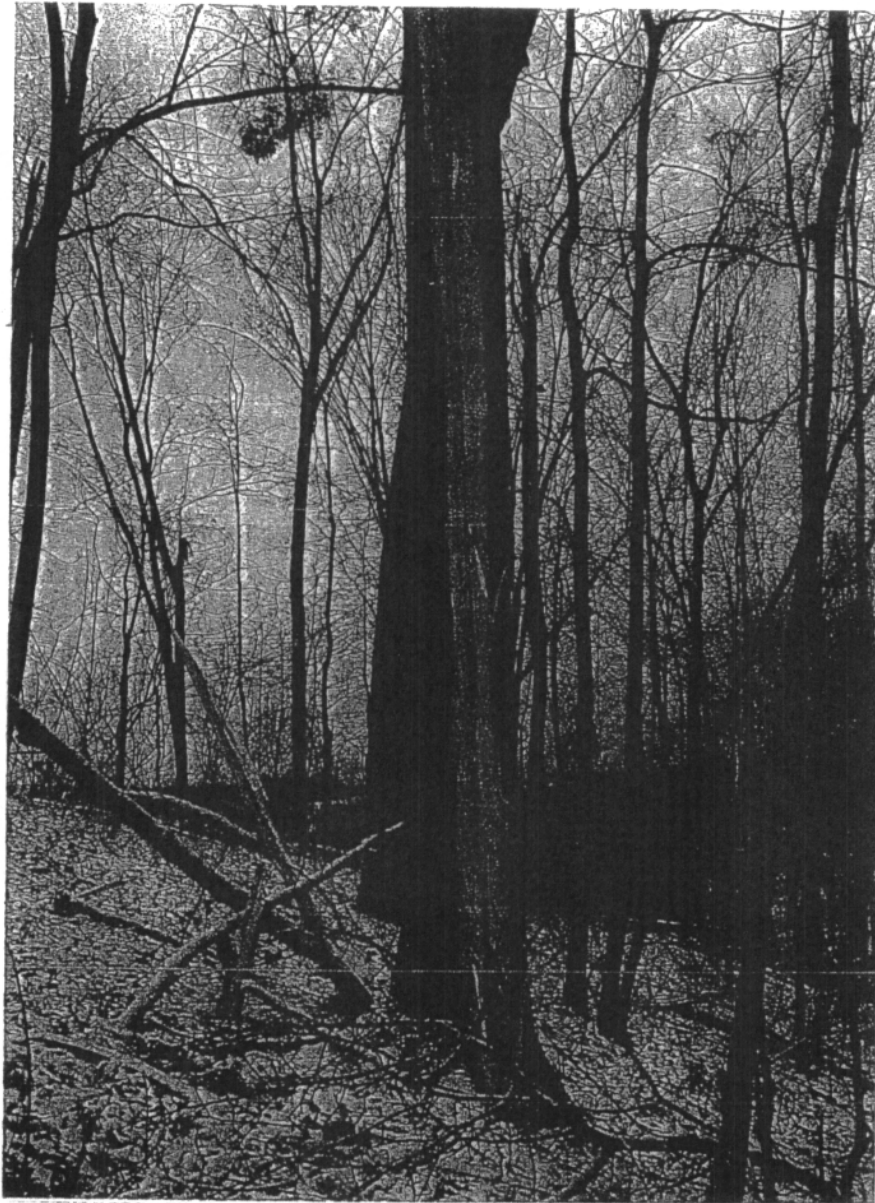
Photo 1. Poplar tree very recently hit by lightning and in close proximity to +110 kA hit recorded by Vaisala (StrikeNet) at LAT 38.926, LONG -80.233 at 06:26:35.680 am on January 2, 2006, Photo by Kermit Melvin, January 6, 2006.
