WORKPLACE SOLUTIONS

From the National Institute for Occupational Safety and Health

Preventing Deaths and Injuries of Fire Fighters Working Above Fire-Damaged Floors

• **DHHS (NIOSH) Publication No. 2009-114**

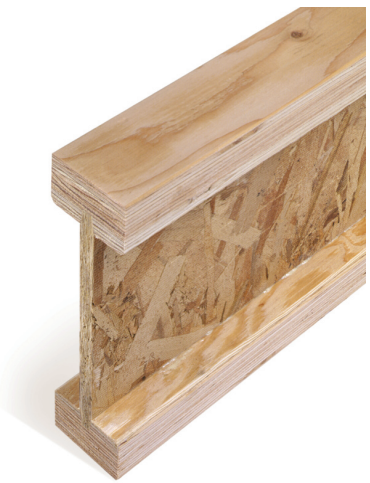
Engineered wood I-joists represent a rising technology in the building sector; they offer several advantages over traditional construction methods. Engineered wood I-joists are typically prefabricated using sawn or structural composite lumber for the top and bottom flanges (usually 1 ½ to 3 ½ inches wide) and plywood or oriented strand board (OSB) sheathing for the vertical web (3/8 to 7/16 inches thick) (see Figure 1). Engineered wood I-joists are lighter, stiffer, and will not warp, twist, or shrink like traditional framing materials.

Figure 1. Engineered wood I-joist. Photo courtesy of APA-Engineered Wood Association.

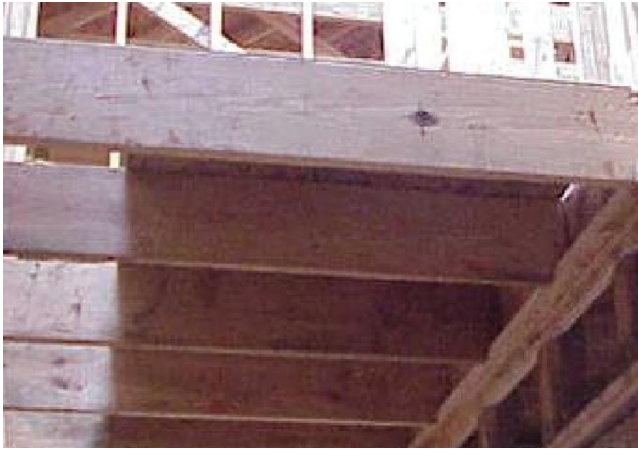
Figure 2. Traditional floor joists.

The engineered wood I-joist has a different cross-sectional profile than a standard solid sawn wood joist (see Figure 2) and in testing, burned more quickly. Typically, the thinner web was consumed first (see Figure 3). Time-to-failure testing has been conducted by several groups, most recently Underwriters Laboratories (UL) [2008]; [Strasleske and Weber 1988; Weyerhaeuser 1986]. The UL tests show that unprotected lightweight engineered floor joist (I-joists) assemblies can fail in as little as 6 minutes, and that traditional unprotected residential floor construction assemblies failed in less than 19 minutes. Previous studies that used different test methods suggested even shorter times-to-failure. These study results indicate that any floor system can fail quickly, and that unprotected engineered wood I-joists may fail sooner. Results from experiments conducted by the National Institute for Standards and Technology (NIST) are expected in the spring of 2009, and will be available at www.fire.gov/. The NIST experiments were conducted in ventilation limited conditions meant to represent an actual basement fire.

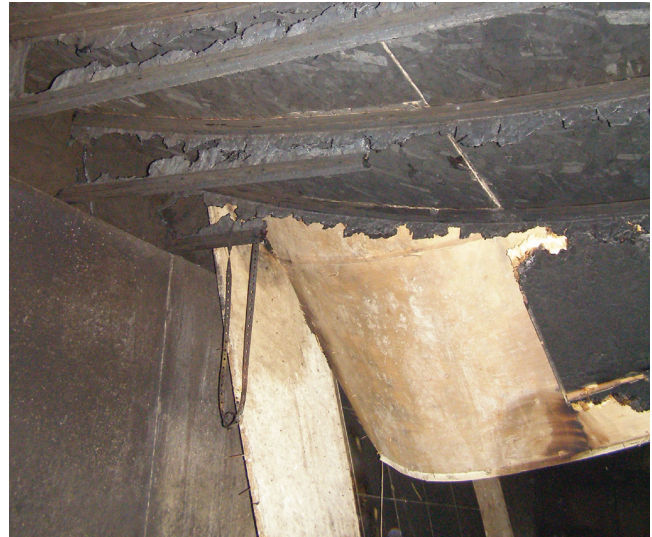
On August 13, 2006, a 55-year-old male career engineer (the victim) died and his partner was injured after they fell through the floor at a residential structure fire. The house was built in 1999, and the first floor contained a

Figure 3. Fire-damaged I-joists where victim fell through floor. Note how the vertical web is almost completely consumed [NIOSH 2006a].

heated flooring system consisting of a hot water piping system encased in lightweight concrete supported by engineered wood I-joists and trusses. The basement was unfinished and the bottom sides of the I-joists and floor trusses were exposed. An engine company was conducting a fast attack on a suspected basement fire, while a ladder company conducted horizontal ventilation. The victim and his partner were conducting a primary search on the ground floor. Smoke filled the ground floor and made visibility near zero, but little heat was detected as the victim and his partner conducted a left-hand search. They sounded the ceramic tile floor and took one crawling step forward on their knees when the floor collapsed. The partner fell on the other side of a basement door into a hallway and crawled out of a basement window. The victim fell into the room of fire origin and was recovered the next day. The floor collapsed about 11 minutes after the initial 911 dispatch [NIOSH 2006].

To minimize risk when working above fire-damaged floors, NIOSH recommends that fire departments and fire fighters take the measures identified below. Many of these prevention measures are from the *NIOSH Alert: Preventing Injuries and Deaths of Fire Fighters due to Truss System Failures* [2005]. Lightweight truss systems and engineered wood floor joists have similar fire degradation risks.

- Builders, contractors, and owners should consider protecting all floor systems, including engineered wood I-joists, by covering the underside with fire-resistant materials [Underwriters Laboratories 2008].
- Builders, contractors, and owners should consider incorporating sprinkler systems into residential construction. Sprinkler use reduces the chances of both residential and fire fighter fatalities [USFA 2008].
