Occupational Exposure to Mercury at an Electronics Waste and Lamp Recycling Facility — Ohio, 2023

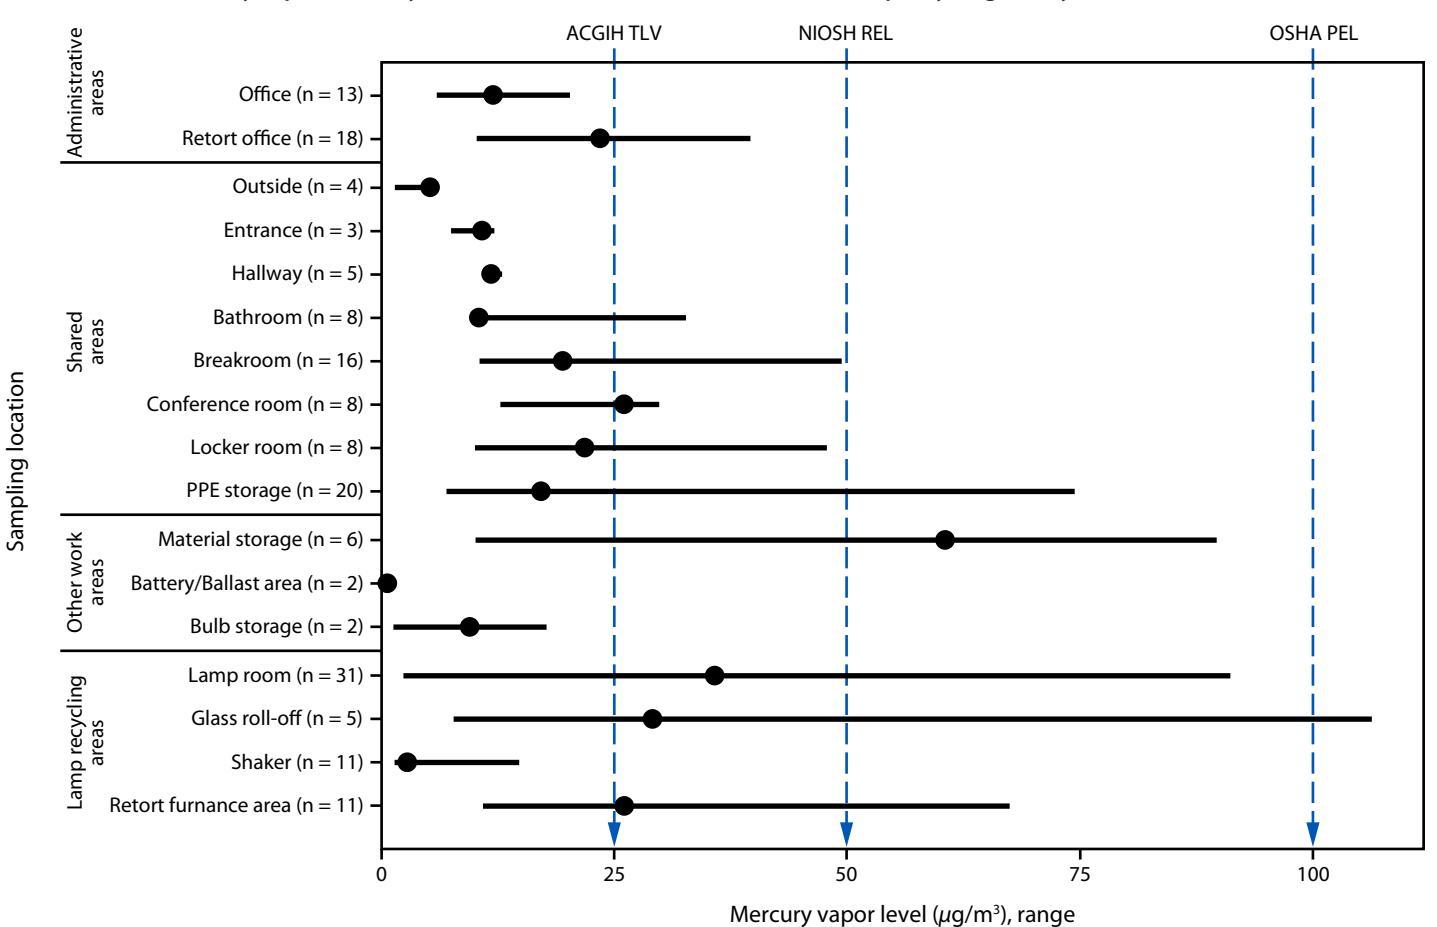
Mercury was detected in all 171 direct area air samples (Figure). In areas outside of the lamp recycling areas (lamp room, glass roll-off, shaker, and retort areas), referred to as nonproduction areas, the median mercury vapor concentrations in the conference room (26.0 μ g/m³; range = 12.8–29.8 μ g/m³) and material storage area (60.5 μ g/m³; range = 10.1–89.7 μ g/m³) exceeded the ACGIH TLV of 25 μ g/m³. The median mercury vapor concentration in the material storage area also exceeded the NIOSH REL of 50 μ g/m³. In production areas, the median mercury vapor concentrations in the lamp room (35.8 μ g/m³; range = 2.5–91.1 μ g/m³), glass roll-off area (29.1 μ g/m³; range = 7.8–106.3 μ g/m³) were also above ACGIH TLV. One sample from the glass roll-off area (106.3 μ g/m³) exceeded both NIOSH REL and OSHA PEL.

FIGURE. Median mercury vapor levels, by work location at an electronic waste and lamp recycling facility — Ohio, 2023

Recommendations to protect workers based on a hierarchy of controls[§] approach were provided to the facility (4). Recommended engineering controls included installing local exhaust ventilation over the conveyer in the lamp room and maintenance of the facility's heating, ventilation, and air conditioning systems. Other recommendations included implementing a workflow progressing from clean to dirty zones to prevent the spread of mercury to clean areas, improving housekeeping, tailoring training in workers' preferred languages, and standardizing use of recommended PPE.
