THE UNITED MINE WORKERS OF AMERICA, AFL-CIO/CLC

REPORT ON THE

Sago Mine Disaster

OF JANUARY 2, 2006

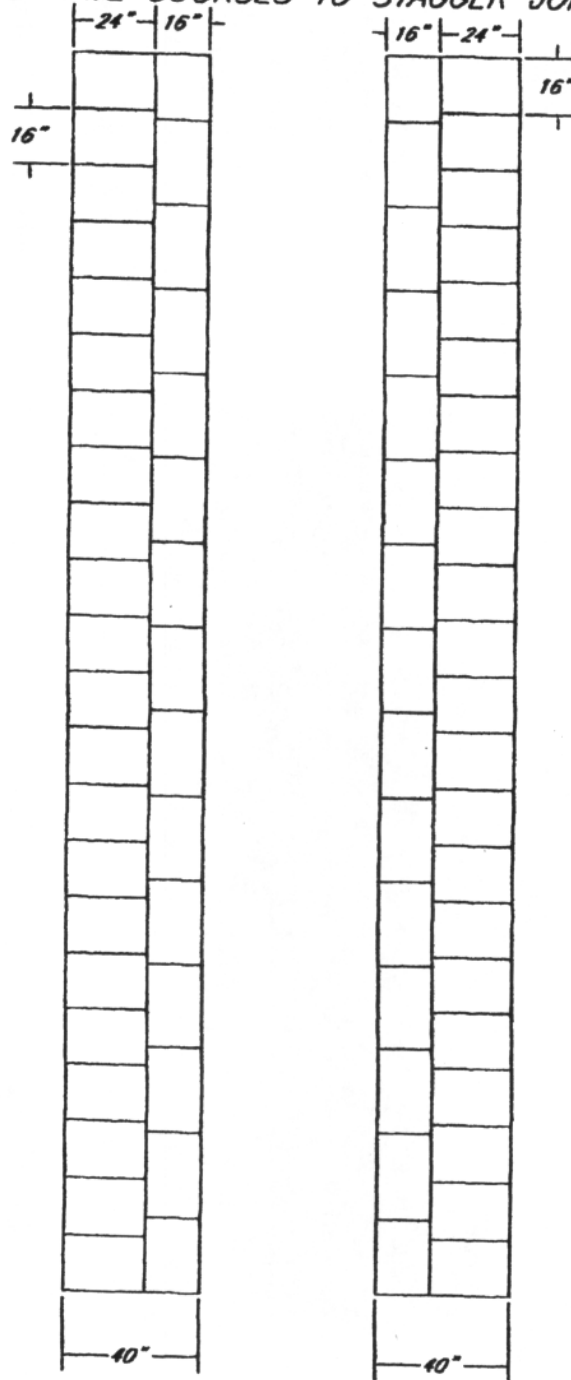
40" THICK OMEGA BLOCK SEAL

1. Total thickness 40 inches
2. No hitching required
3. Joints must be staggered
4. All joints shall be a minimum $\frac{1}{4}$ inch thick and be motared using an approved motor/sealant
5. Three rows of wood planks running the entire length of the seal shall be installed across the top of the seal
6. Wedges will be placed on 1' centers or less with an approved sealant used to fill the gaps
7. An approved sealant shall be used as full face coating on both sides of the seal.

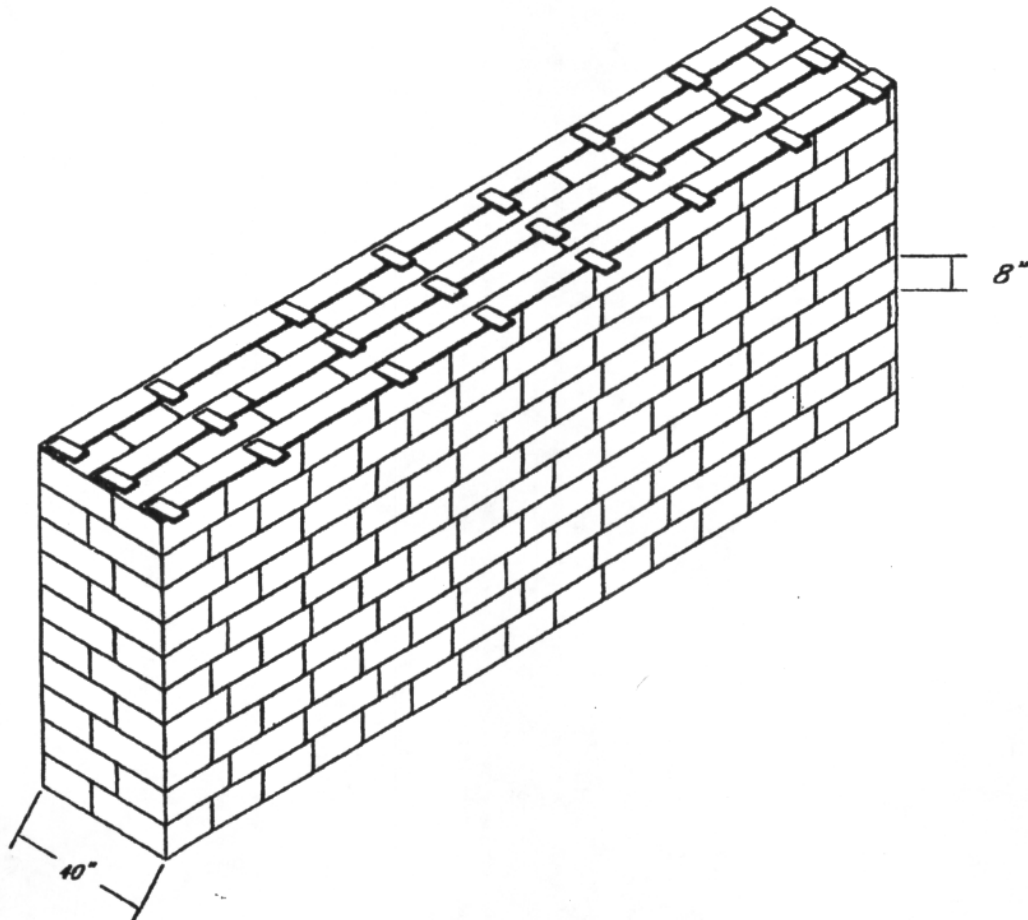
*40" THICK OMEGA BLOCK SEAL
FOR USE WITH SEALS UP TO 8 FT HIGH BY 20 FT WIDE
NO HITCHING REQUIRED*

1. Total thickness of completed seal shall be 40 inches
2. No hitching required
3. Joints must be staggered
4. All joints shall be a minimum $\frac{1}{4}$ inch thick and be mortared using "BlockBond"
5. Three rows of wood planks running the entire length of the seal shall be installed across the top of the seal
6. Wedges will be placed on 1' centers or less with "BlocBond" used to fill the gaps
7. "BlocBond" shall be used as full face coating on both sides of the seal.
