Evaluation of Decontaminated N95 Respirators

Respirator Model: 3M 1870

Tests: Filtration with NaCl (modified version of STP-0059), Manikin Fit Factor with Static Advanced Headform, and Strap Integrity with Tensile Testing

Decontamination Method: Gaseous ozone, 450 ppm

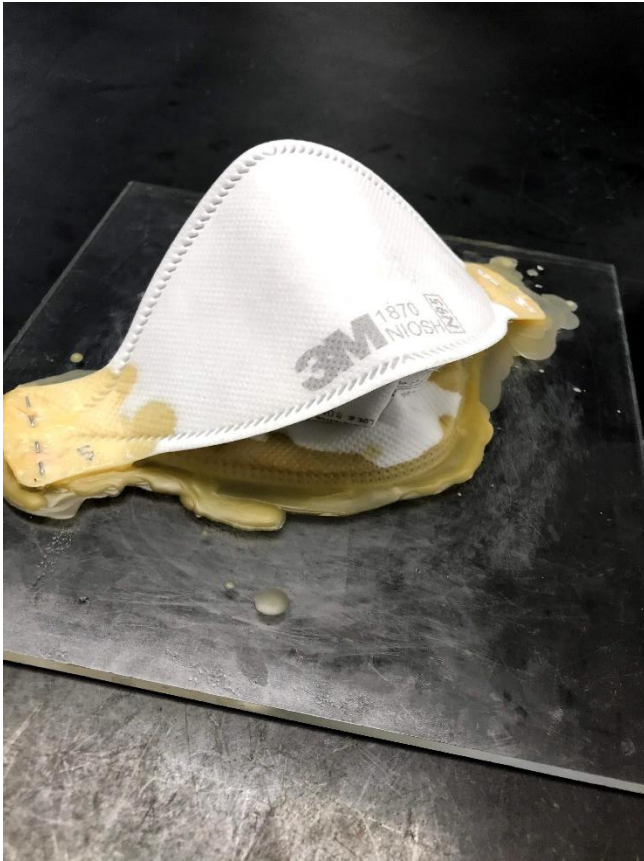
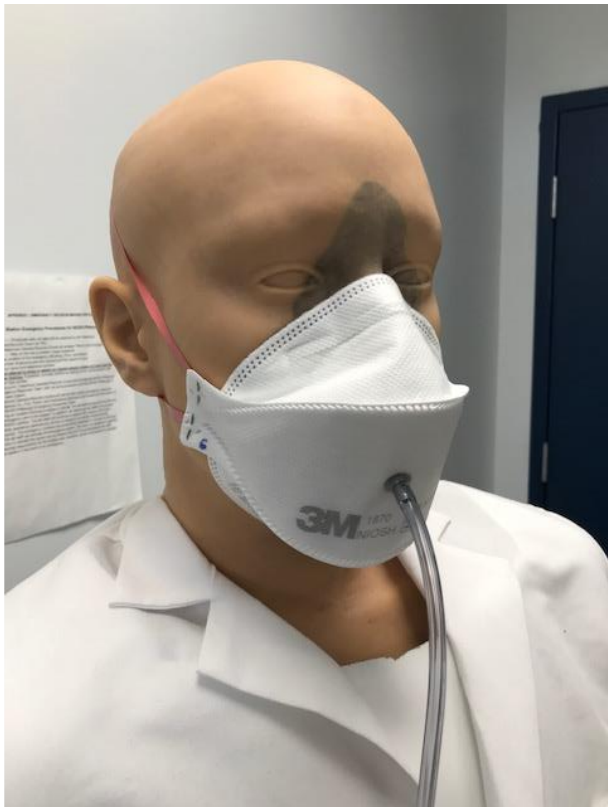
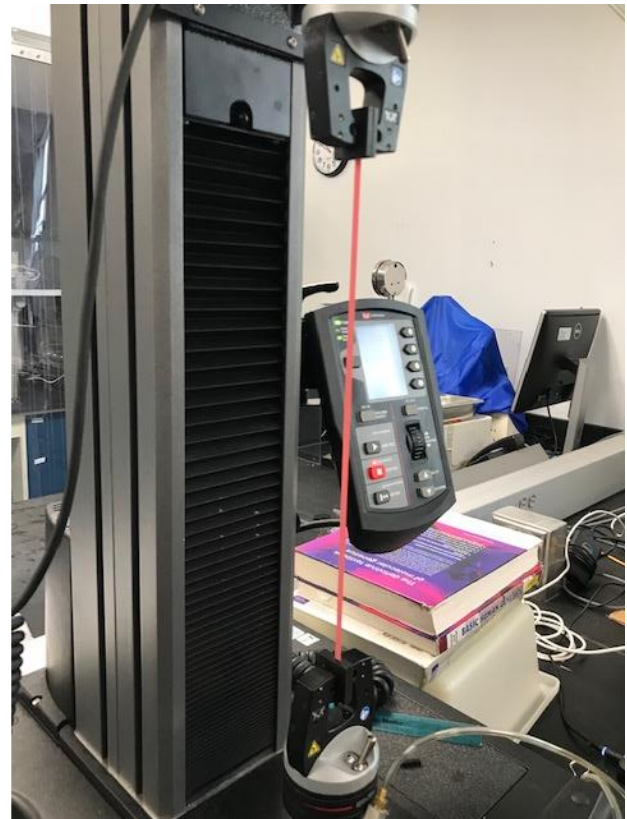
Figure 1. Laboratory Test Photos

15 respirators that were unworn and not subjected to any pathogenic microorganisms were submitted for evaluation. 10 respirators were subjected to 5 cycles of the gaseous ozone decontamination process. An additional 5 controls were provided. Figure 1 photos document the procedures used. The samples were tested using a modified version of the NIOSH Standard Test Procedure (STP) TEB-APR-STP-0059 to determine particulate filtration efficiency. The TSI, Inc. model 8130 using sodium chloride aerosol was used for the filtration evaluation. For the laboratory fit evaluation, a static manikin headform was used to quantify changes in manikin fit factor. The TSI, Inc. PortaCount® PRO+ 8038 in “N95 Enabled” mode was used for this evaluation. Additionally, tensile strength testing of the straps was performed to determine changes in strap integrity. The Instron® 5943 Tensile Tester was used for this evaluation. The full assessment plan can be found [here](#).
